FRIGIDAIRE SERVICE

# Tech-Talk

Volume XII, No. 6

November 1960

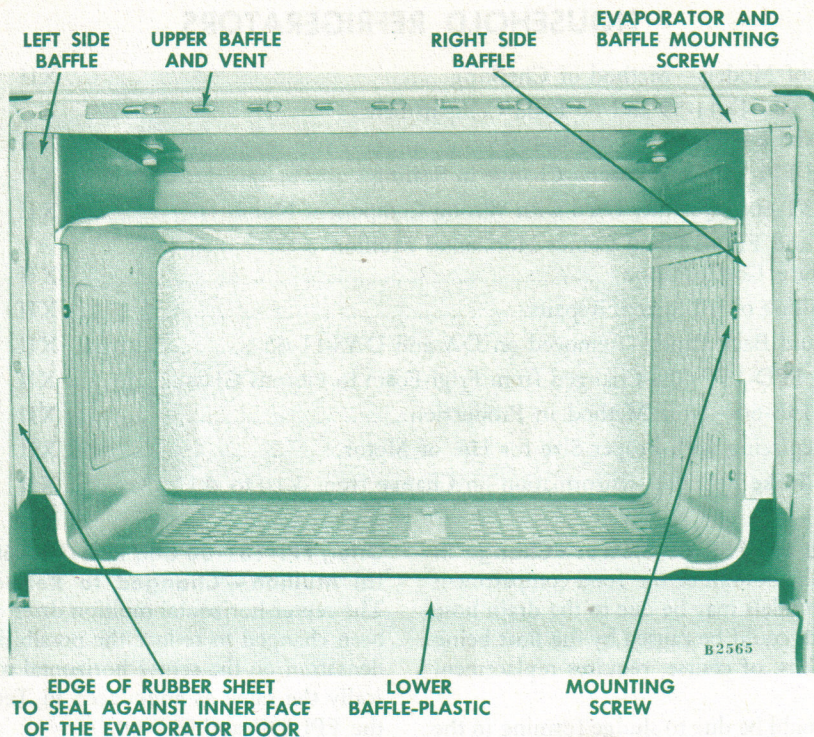
Figure 1

**Baffle, D-13-59 and 60 and D-11-59 and 60 Food Compartment—Kit Available to Prevent Freezing Temperatures:** A baffle kit, Piece No. 6590477, will be available early in June to prevent freezing temperatures in D-11-59 and 60 and in D-13-59 and 60 food compartments. This is accomplished by restricting the natural flow of air around the evaporator.

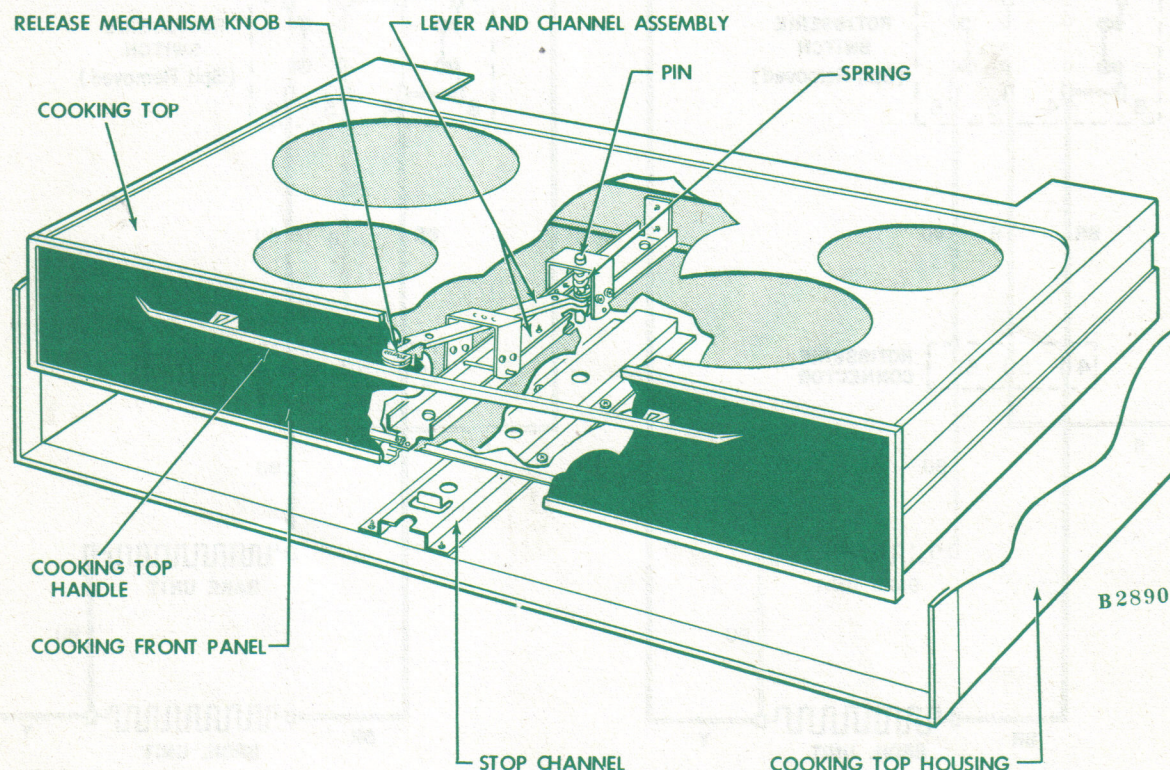
Figure 14

The release handle, formerly located above the cooking top cover at the left side of the range, now is positioned directly behind the center of the cooking top handle, Figure 14.

At the time the release knob is depressed, the pivoted latch lever moves downward at the front and upward at the rear. The upward movement depresses the latch pin operating spring. A retaining ring, mounted to the pin immediately below the spring, is in contact with the latch lever and, at the same time the spring is depressed, the latch pin is lifted free of the hole in the stop channel.

Replacement parts, if needed, are available from your Frigidaire Distributor for both the new style and old style release mechanism design.

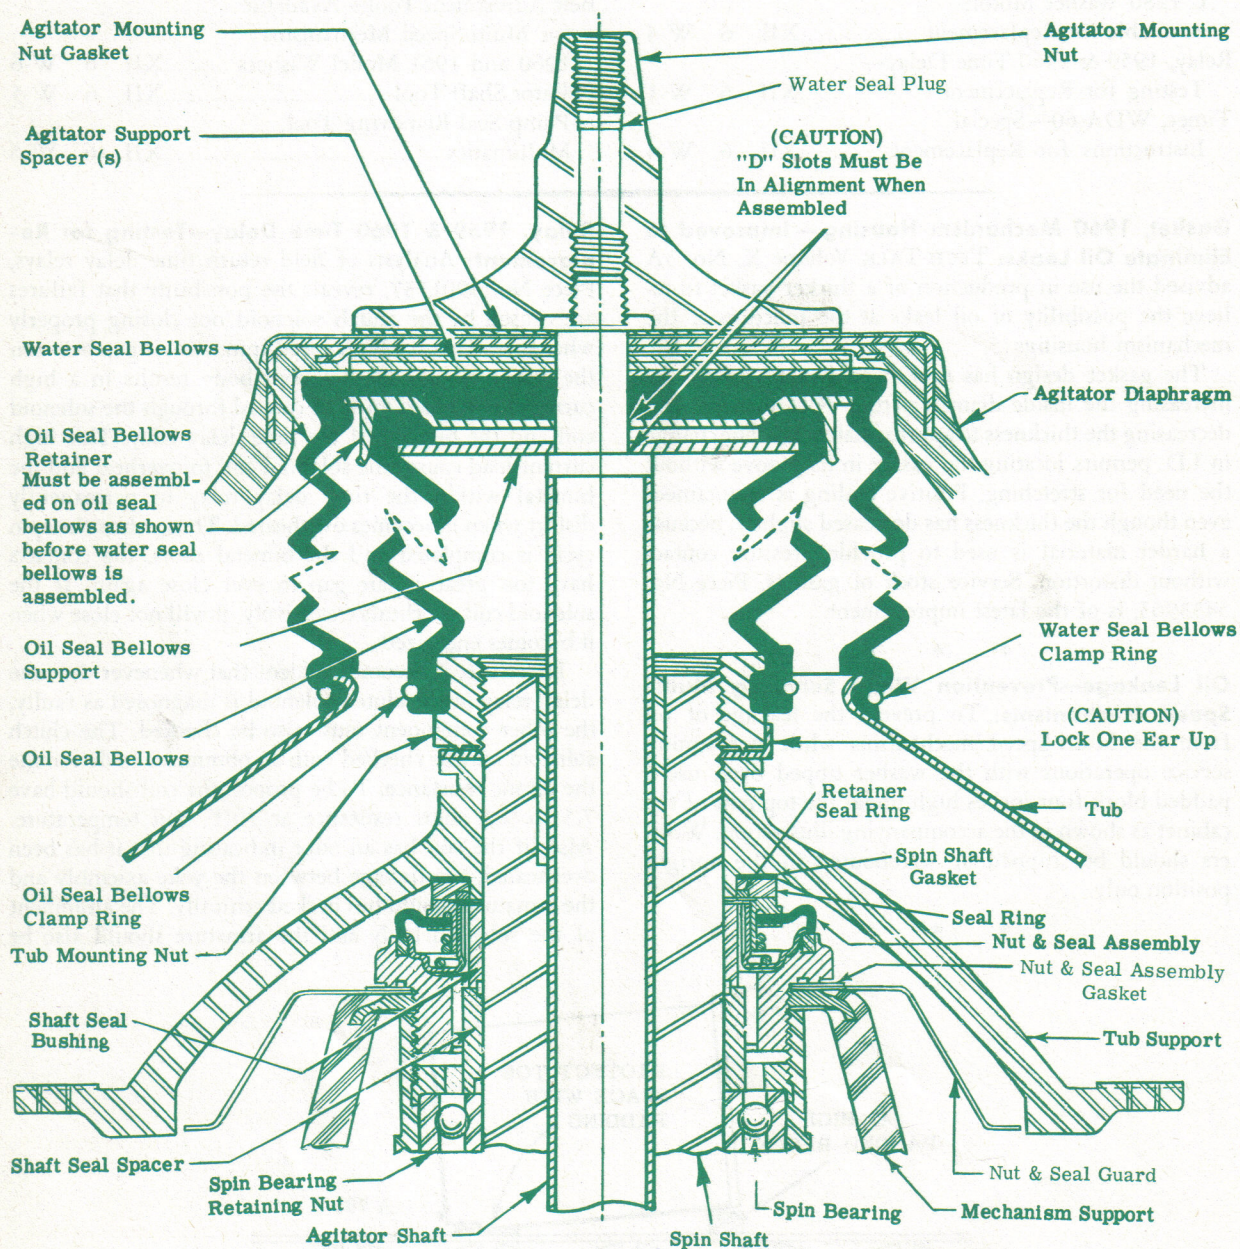
Figure 17

Field contacts on washer problems indicate that a large percentage of mechanism failures are due to improperly

reassembled water and oil seal bellows by field servicemen. It is of the utmost importance that these bellows; and related parts, be assembled properly to prevent leakage at the top of the oil seal bellows. This is necessary to prevent water and moisture laden vapors from entering the mechanism to cause eventual mechanism failure.

The top of the oil seal bellows must seat fully against the bottom side of the retainer to prevent leakage.

The following procedure is necessary to obtain proper assembly:

- groove at the inside top of the seal bellows.
2. Rotate the tub counterclockwise until the agitator shaft rises to the top of its stroke.
  3. Place the oil seal bellows snap ring over the bottom of the bellows and install onto the pulsator shaft. Position the D hole, in the oil seal bellows support, in proper alignment on the shaft in relation to the flat of the shaft.

5. Install the oil seal bellows retainer onto the pulsator shaft and down over the oil seal bellows. *Work the top of the oil seal bellows up inside the retainer flange to seat fully as shown in the illustration. If proper sealing between the top of the oil seal bellows and retainer is not obtained—water leakage into the mechanism will result.*
