FRIGIDAIRE SERVICE

# Tech-Talk

Volume XII, No. 6

November 1960

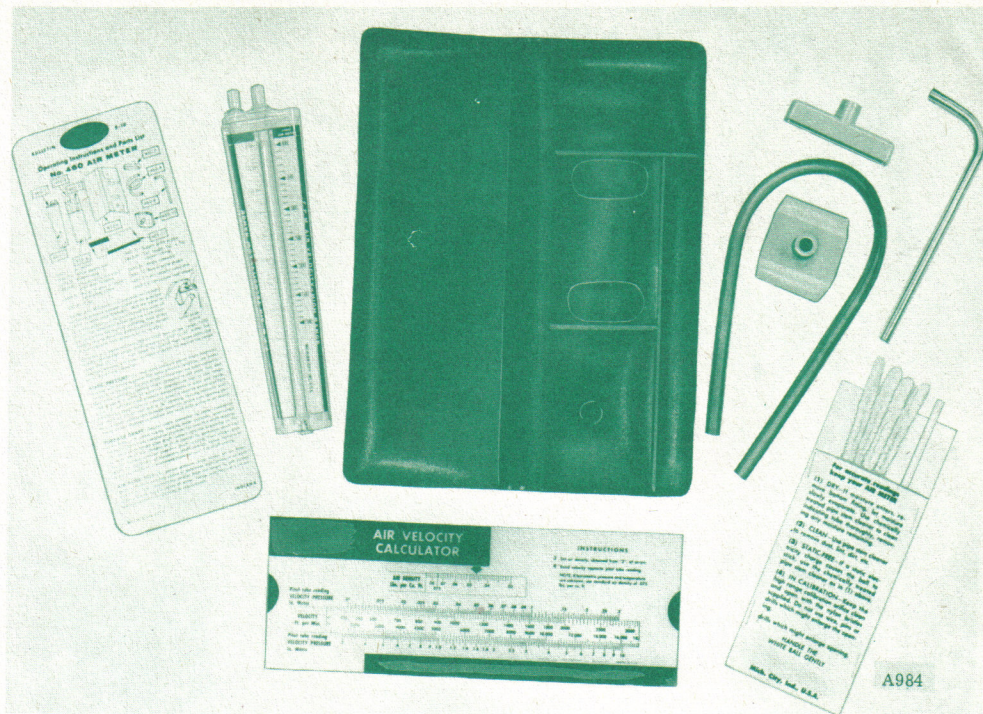
Figure 2

This air flow can be checked by using an air velocity indicator Tool No. 12228 (illustrated in Figure 2) to measure the speed of the air through the discharge grille in feet per minute.

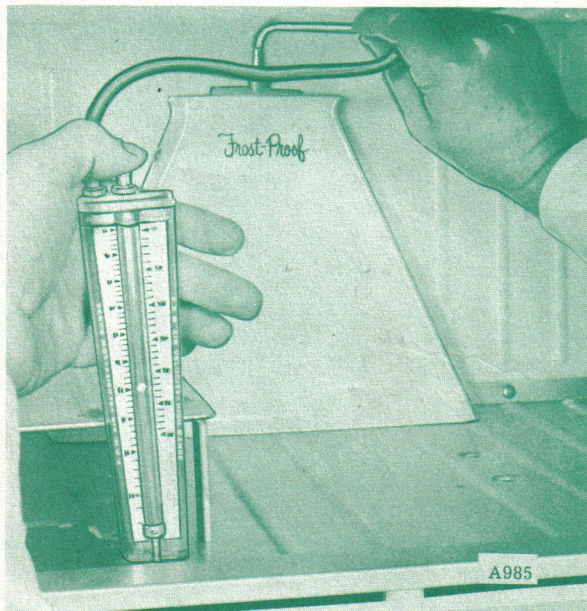
Figure 3

To check the freezer air discharge, hold the air flow meter tube as illustrated in Figure 3, place your thumb over the discharge outlet of the meter, and read the scale on the right side, at the point where the pith ball is floating. This should read approximately 1500 to 2000 F.P.M. If the reading is considerably less than 1500, there is probably an air flow restriction that should

be corrected. This may be in the form of a restricted passage, a binding fan motor, or it could be an accumulation of ice on the evaporator due to inadequate defrosting.

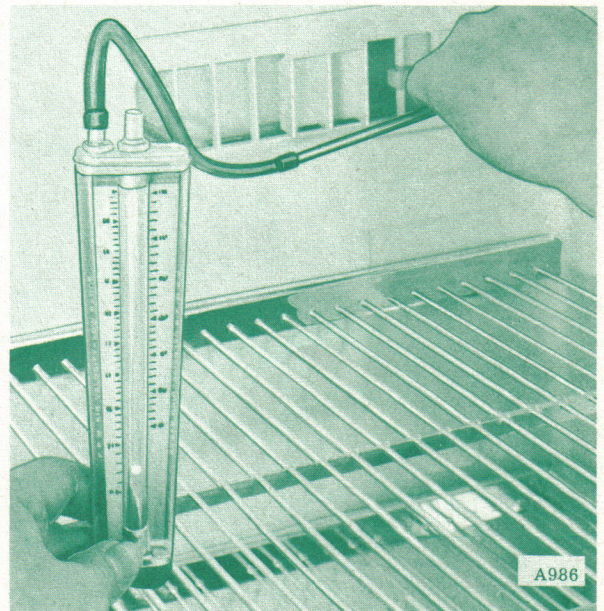
Figure 4

To check the food compartment air velocity, use the procedure shown in Figure 4. On some models removal of the supply grille probe will give better results. In the lower velocity range, do not block off the discharge tube of the meter. At this point the velocity should read between 300 and 400 F.P.M. If the air flow is low, check for restrictions and proper fan speed.

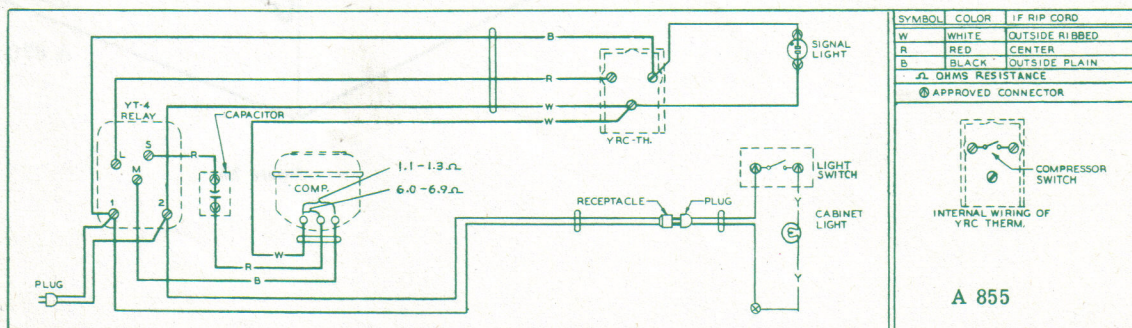
Figure 27

Approximately 500 CFB-20 Food Freezers were built using the YG-4 relay; those built after Serial No. 40AA9928 use the new relay. Model UFPI-16-60 and UFPD-16-60 Food Freezers will continue to use the YG-4 relay until the present production stock is depleted.

The accompanying figure shows the new CFB-20 wiring diagram.
